Vehicle Integrated Propulsion Research (VIPR) III Volcanic Ash Ingestion Testing

**AVT-272 Specialists Meeting on “Impact of Ash
Clouds on Military Operations”**

**John D. Lekki and Mark R. Woike
NASA Glenn Research Center**

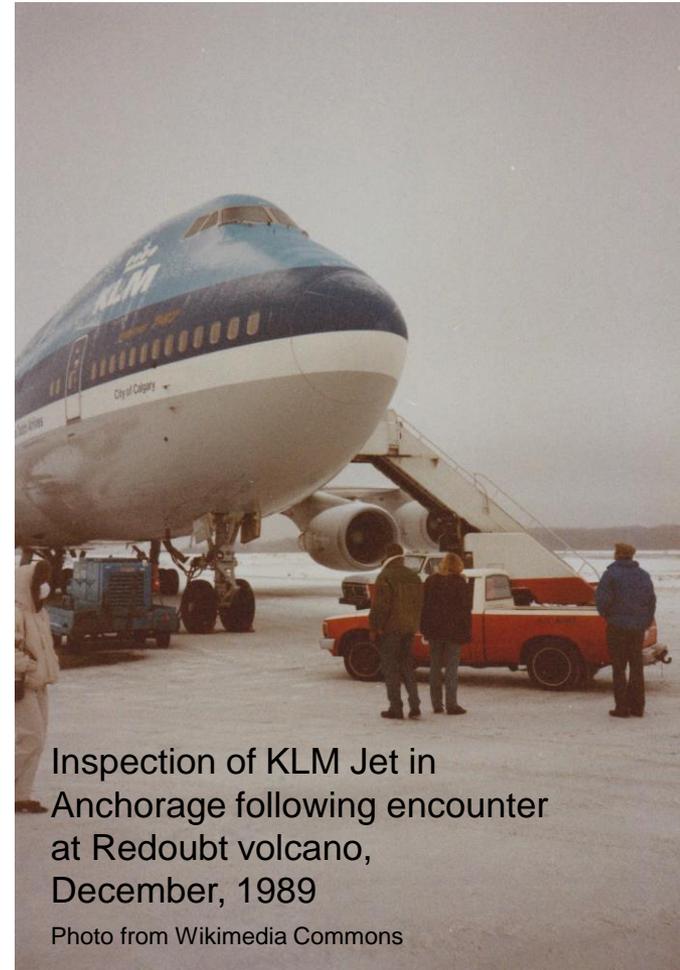
Inspection of KLM Jet in Anchorage following encounter at Redoubt volcano, December, 1989

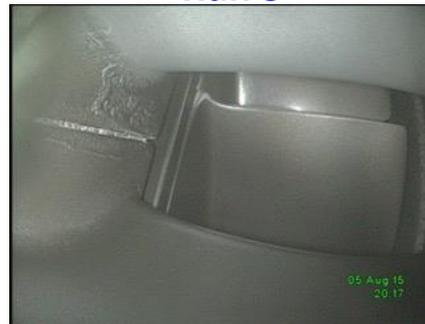
Observations – Compressor Degradation

- No issues observed with blades or vanes

- HPC very clean, no obvious wear or discoloration
- Mild ash accumulation on 10th stage bleed cap

- No noticeable changes

- No degradation observed

Note: Some degradation later observed in compressor during engine teardown. Will be discussed in next section of presentation.

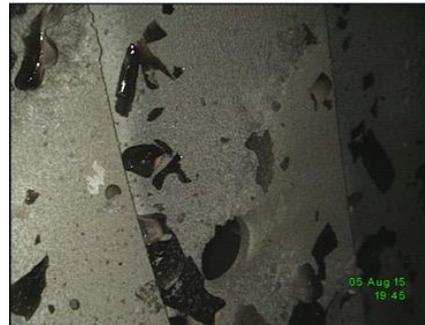
Observations – Combustor Degradation

- Baseline state looks clean

- No major changes from baseline

- Shedding material starting to show up in combustor area
- Other areas around the fuel nozzle show some very local ash accumulation

- Showing large thin flakes of ash shedding

- Similar to first high flow run day (Run 4) showing large thin flakes of ash shedding

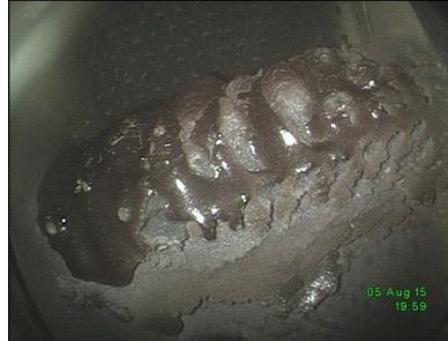
First Stage Turbine Vanes

Observations – First Stage Turbine Vane Degradation

- No issues with vanes, No appearance of coating or alloy burning

- No evidence of ash accumulation on turbine parts
- Slight plugging of cooling holes in first stage turbine vane
- Cooling air still flowing, not a concern to continue running

- Slight ash seen on first vane leading edge
- No ash seen on gauge point area of 1st vane

- More build up
 - 1st vanes leading edge and forward pressure side
- Aft pressure side gauge area (A4)
 - No built up thus not reducing the gauge area

- 1st stage turbine vanes
 - Build up appears to be glassified ash as expected
 - Gauge point region, still not significantly closed down

- Build up and shedding looks similar to Run 4
 - Gauge area (A4) still not built up

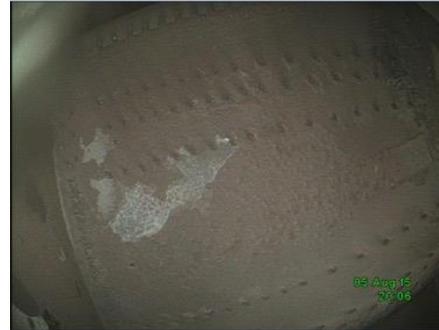
First Stage Turbine Rotor

Observations – 1st Stage Turbine Rotor Degradation

- TBC intact, no blade distress
- Darker areas on blades potentially soot from shutdown, no appearance of coating or alloy burning

- No major changes from baseline

- No ash seen on first blade
- 1st blade outer edge seal leading edge region
 - May have small ash particles

- 1st stage blades , Still show very little effect of the ash
- Turbine ash accumulation is still very low

- 1st blades still are relatively clean but starting to show some accumulation

- Slight build up on some 1st blade leading edges
- Assume it's ash, but did not look “glassified”

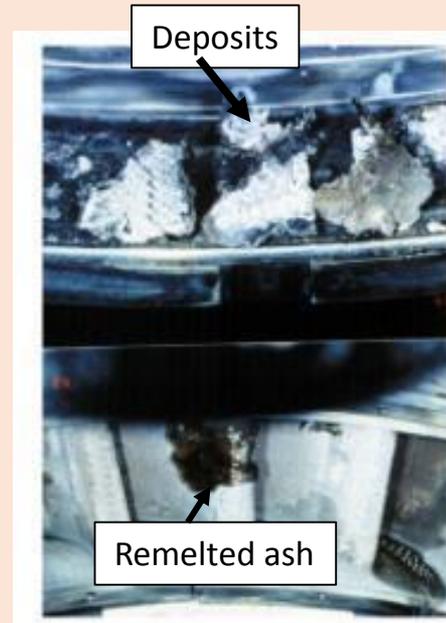
Stage I HPT
Nozzle guide vanes

- Much of our knowledge has come from descriptions of damage to the KLM Redoubt engines, published by Przedpelski and Casadevall (1994).
- In that study, they
 - Observed melted deposits coating the Stage I HPT and nozzle guide veins, as shown to the right.
 - They concluded that *“The primary cause of engine thrust loss . . . was the accumulation of melted and resolidified ash on the stage-1-turbine nozzle guide vanes.”*¹
- From this work, it is generally assumed that:
 - Ash softens, sticks to moving parts, and stops them from operating; and that
 - Softened ash clogs nozzle guide vane holes, causing heat damage
