Vehicle Integrated Propulsion Research (VIPR) III Volcanic Ash Ingestion Testing

**AVT-272 Specialists Meeting on “Impact of Ash
Clouds on Military Operations”**

**John D. Lekki and Mark R. Woike
NASA Glenn Research Center**

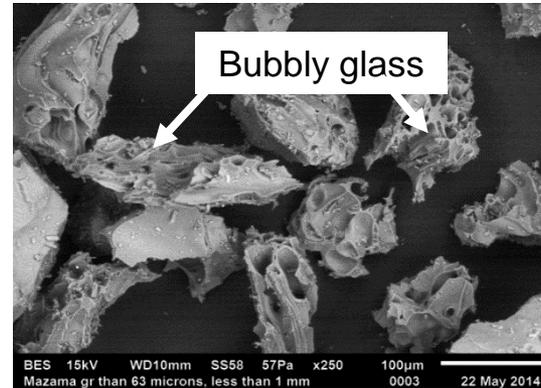
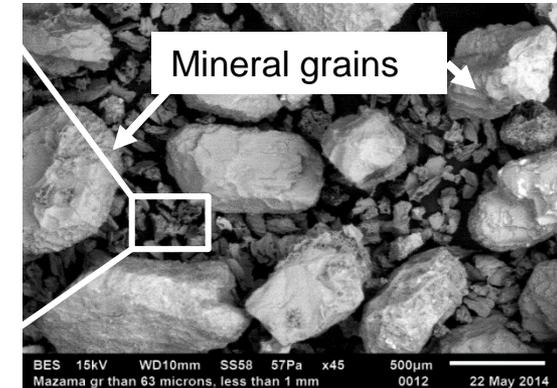
Natural ash fragments from deposit

- The natural deposit contained about
 - 10% mineral grains
 - 90% bubbly glass
- The milled and processed ash contained no mineral grains that we could find
- We think that most mineral grains were separated out during processing

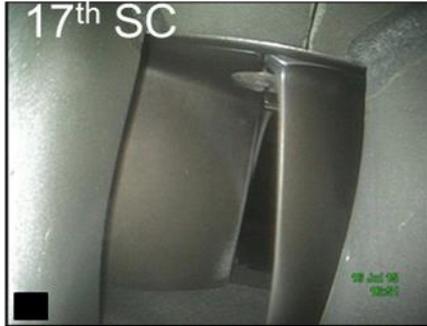
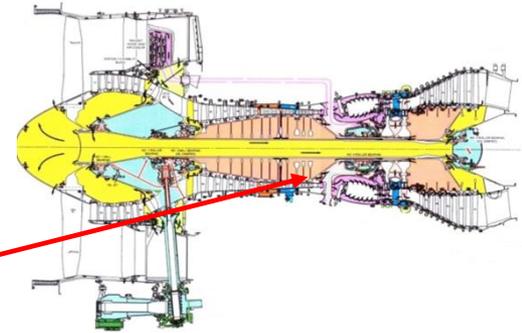
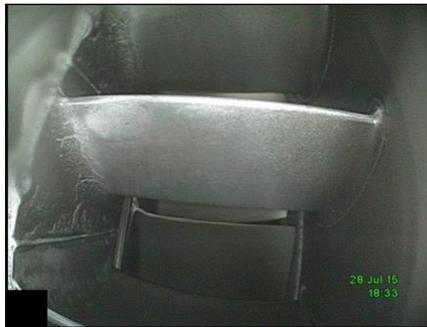
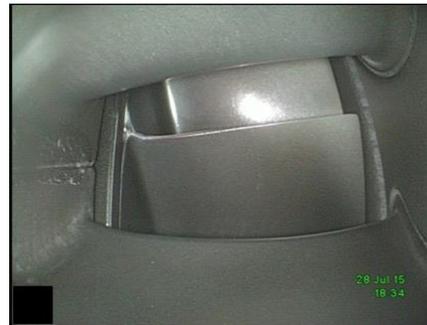
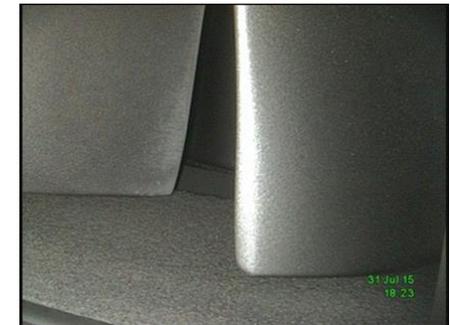
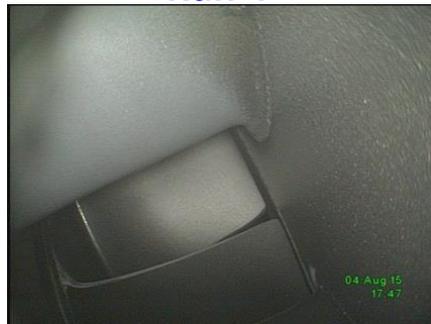
Summary – Compressor Degradation

- No issues observed with blades or vanes

- HPC very clean, no obvious wear or discoloration
- Mild ash accumulation on 10th stage bleed cap

- No degradation observed

Note: Some degradation later observed in compressor during engine teardown. Will be discussed in next section of presentation.

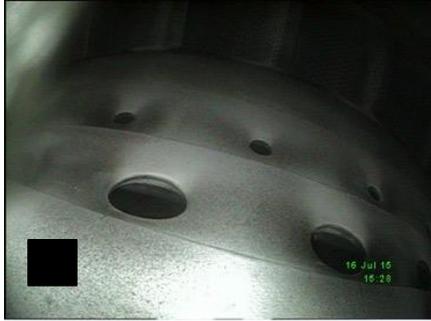
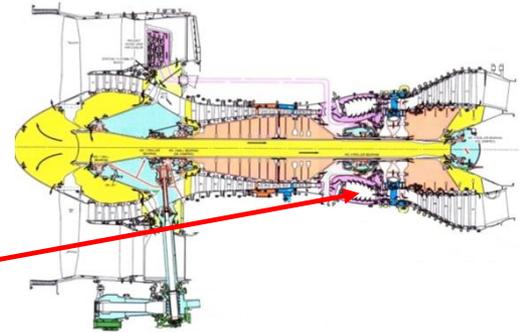
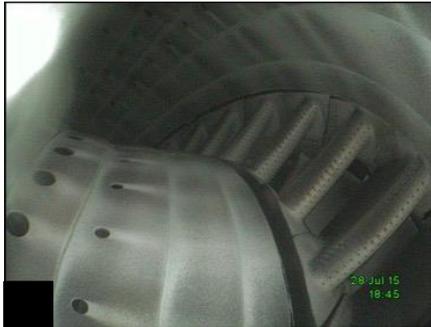
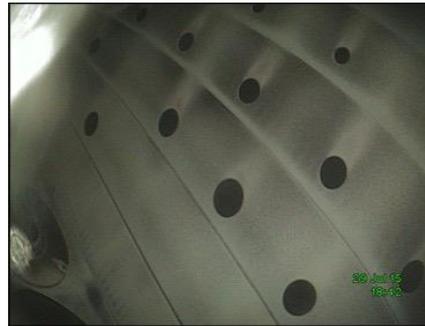
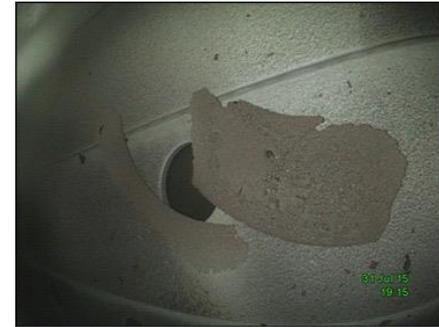
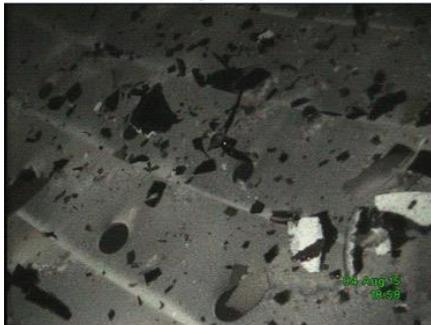
Summary – Combustor Degradation

- Combustor
 - Inner and outer combustor liner intact with no evidence of distress
 - Ash accumulation on inner and outer liner surfaces with additional build up in the outer cavity between the burner and diffuser case. Inner liner had a light tan ash deposits aft of the cooling holes
 - Green tint on outside wall of outer basket, increasing further aft
 - Combustor was more difficult to remove than typical
 - Glass-like deposits found at 6 o'clock position when engine held horizontal
 - Fuel nozzle air holes had significant ash build up but did not appear to obstruct air flow

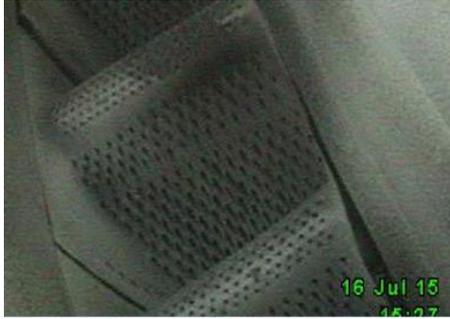
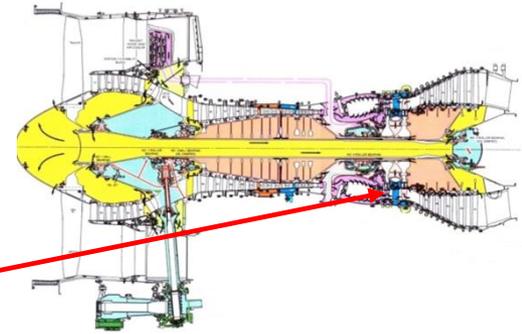
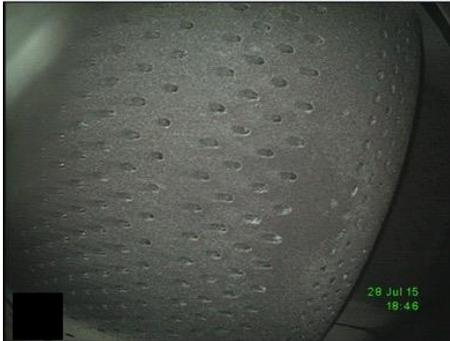
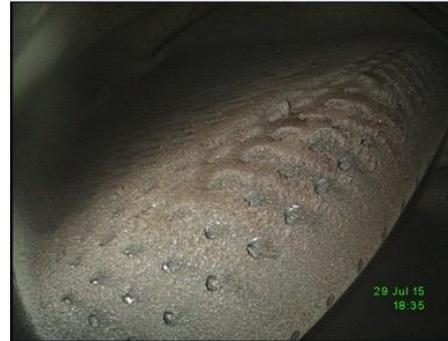
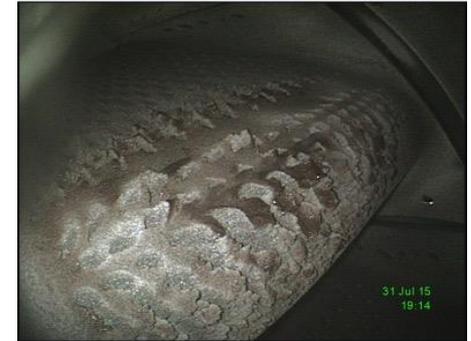
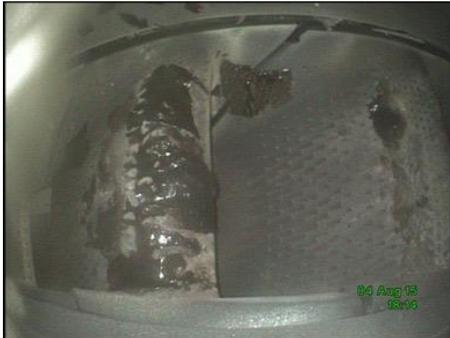
Summary – First Stage Turbine Vane Degradation

- No issues with vanes, No appearance of coating or alloy burning

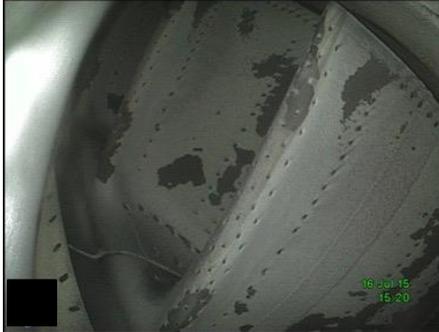
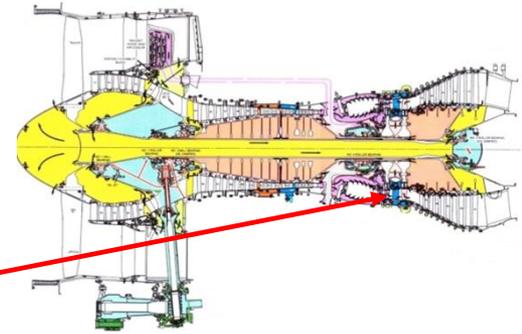
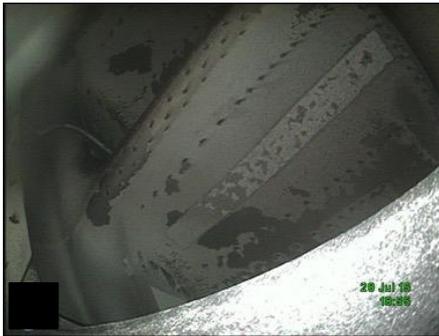
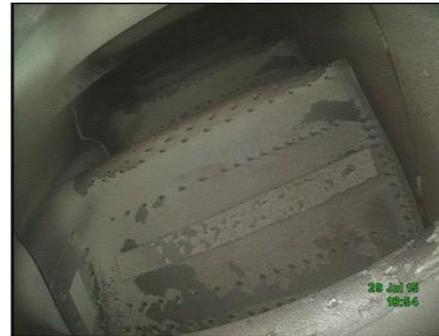
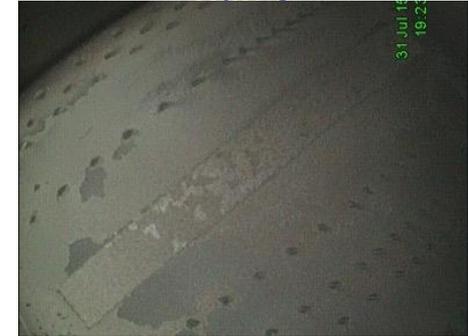
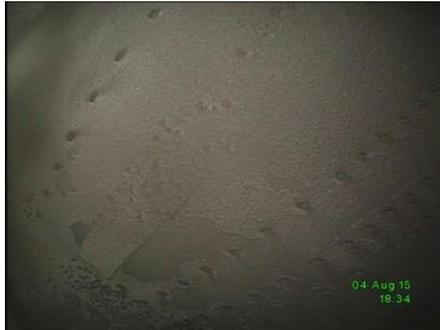
Summary – 1st Stage Turbine Rotor Degradation

- TBC intact, no blade distress
- Darker areas on blades potentially soot from shutdown, no appearance of coating or alloy burning

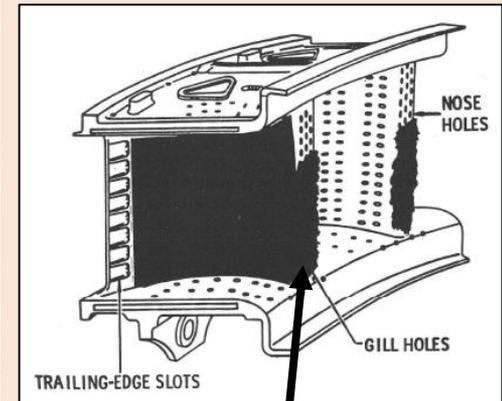
Stage I HPT
Nozzle guide vanes

- Much of our knowledge has come from descriptions of damage to the KLM Redoubt engines, published by Przedpelski and Casadevall (1994).
- In that study, they
 - Observed melted deposits coating the Stage I HPT and nozzle guide veins, as shown to the right.
 - They concluded that *“The primary cause of engine thrust loss . . . was the accumulation of melted and resolidified ash on the stage-1-turbine nozzle guide vanes.”*¹
- From this work, it is generally assumed that:
 - Ash softens, sticks to moving parts, and stops them from operating; and that
 - Softened ash clogs nozzle guide vane holes, causing heat damage

Holes clogged with ash

KLM 747 engines following 1989 Redoubt encounter
(figures from Przedpelski & Casadevall, 1994)
