Volcanic Ash and Gas Turbine Aero Engines - Update

WMO VAAC 'Best Practice' Workshop
5th- 8th May 2015

Rolls-Royce

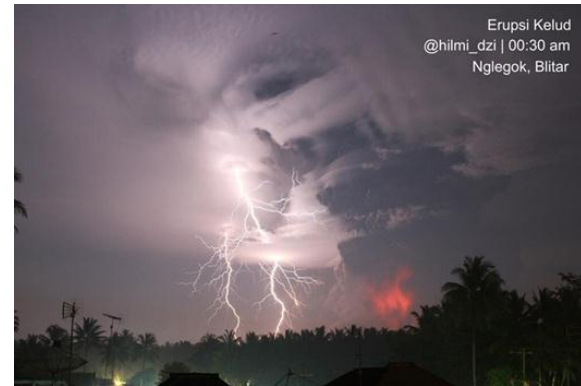
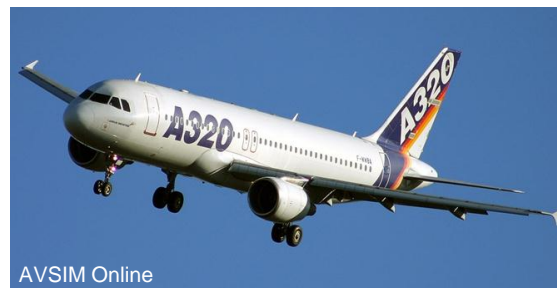
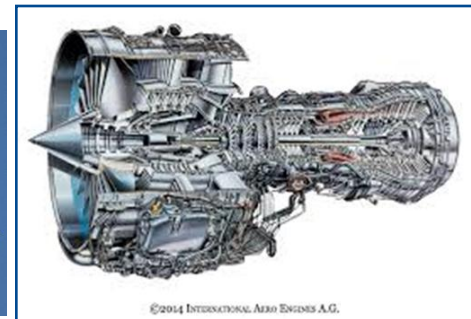
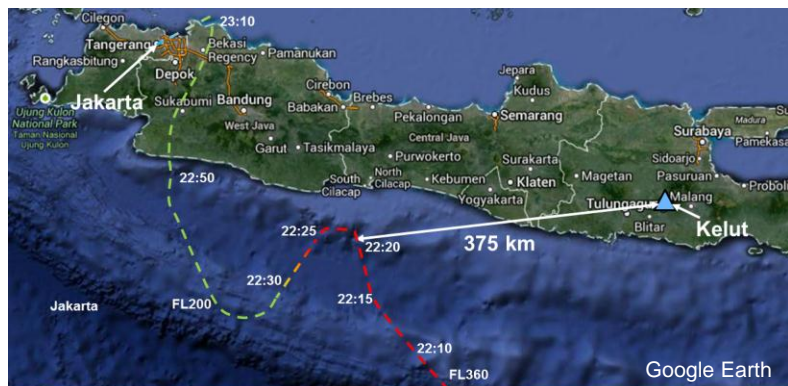
- Late evening on 13th February 2015 (local time) Kelut erupts
- 2.5 hours later an A320, powered by IAE V2527-A5 engines takes off from Perth, WA, destination Jakarta
- Just over 3 hours later aircraft entered ash cloud 375 km from Kelut

- Followed by safe landing at Jakarta
- Engine inspection
 - Evidence of ash deposit in combustor and HP turbine
 - Engines removed for strip and repair

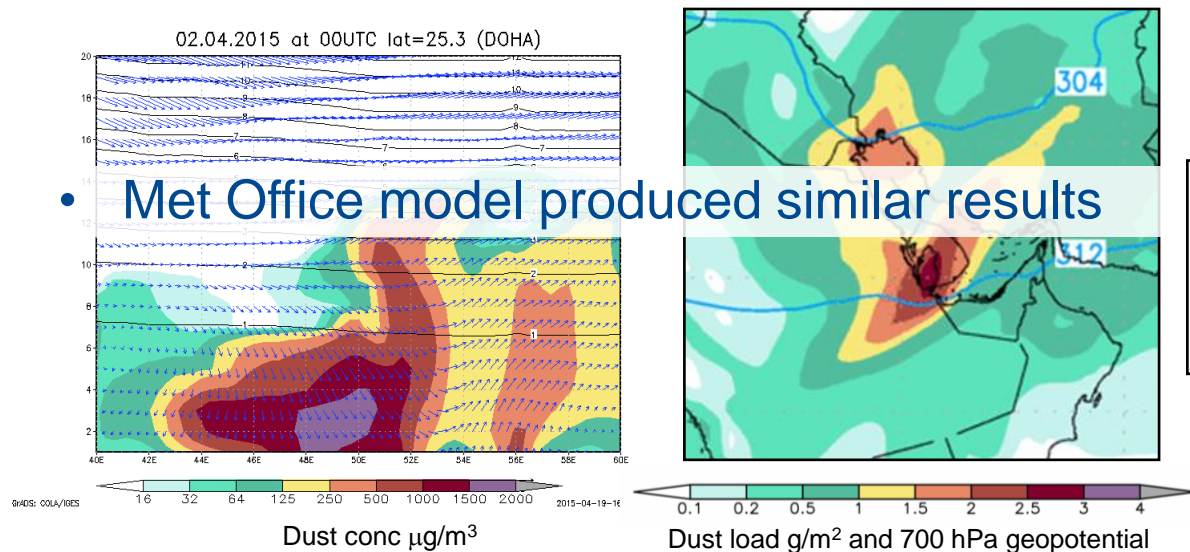
Dust forecast by Slobodan Nickovic – Dust Regional Atmospheric Model (Nickovic et al, 2001; Vukovic et al, 2014)
Horizontal resolution – 0.25 deg; 28 vertical levels

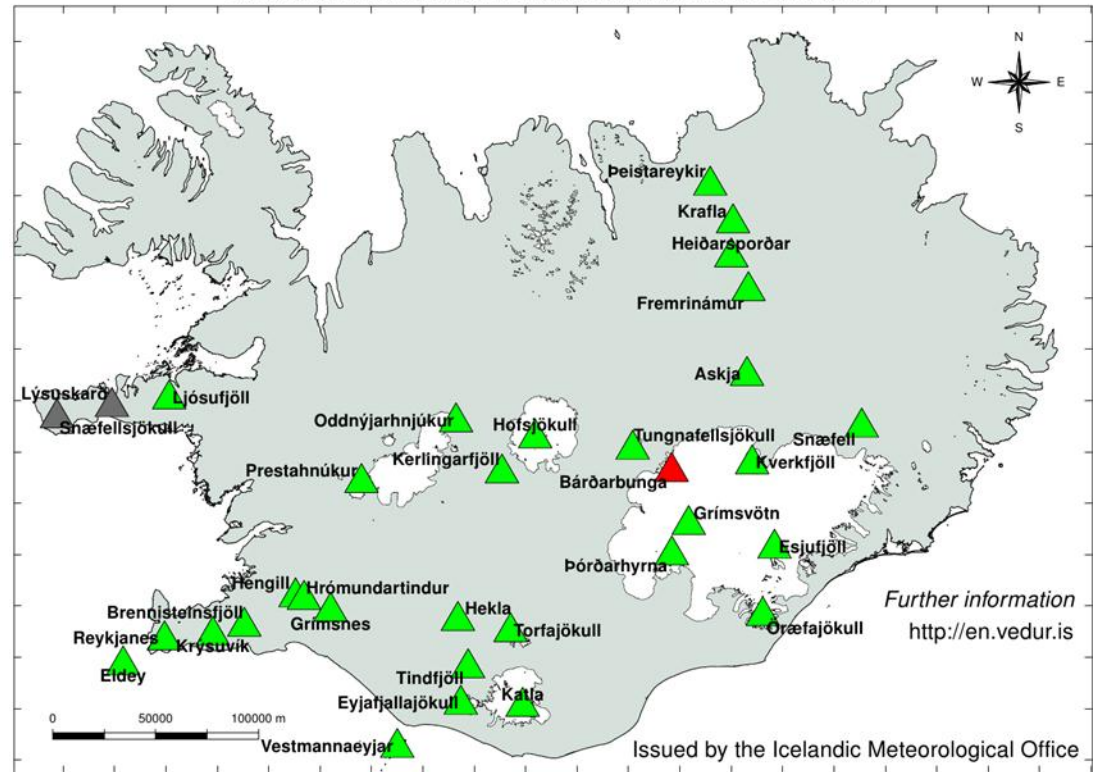
Aviation Colour Codes for Icelandic Volcanic Systems

Aviation colour codes used by the Icelandic Meteorological Office

- ▲ GREY: Volcano appears quiet but is not monitored adequately. Absence of unrest unconfirmed.
- ▲ GREEN: Volcano is in typical background, non-eruptive state.
- ▲ YELLOW: Volcano is exhibiting signs of elevated unrest above known background level.
- ▲ ORANGE: Volcano is exhibiting heightened or escalating unrest with increased potential of eruption.
- ▲ RED: Eruption is imminent or in progress – significant emission of ash into the atmosphere likely.

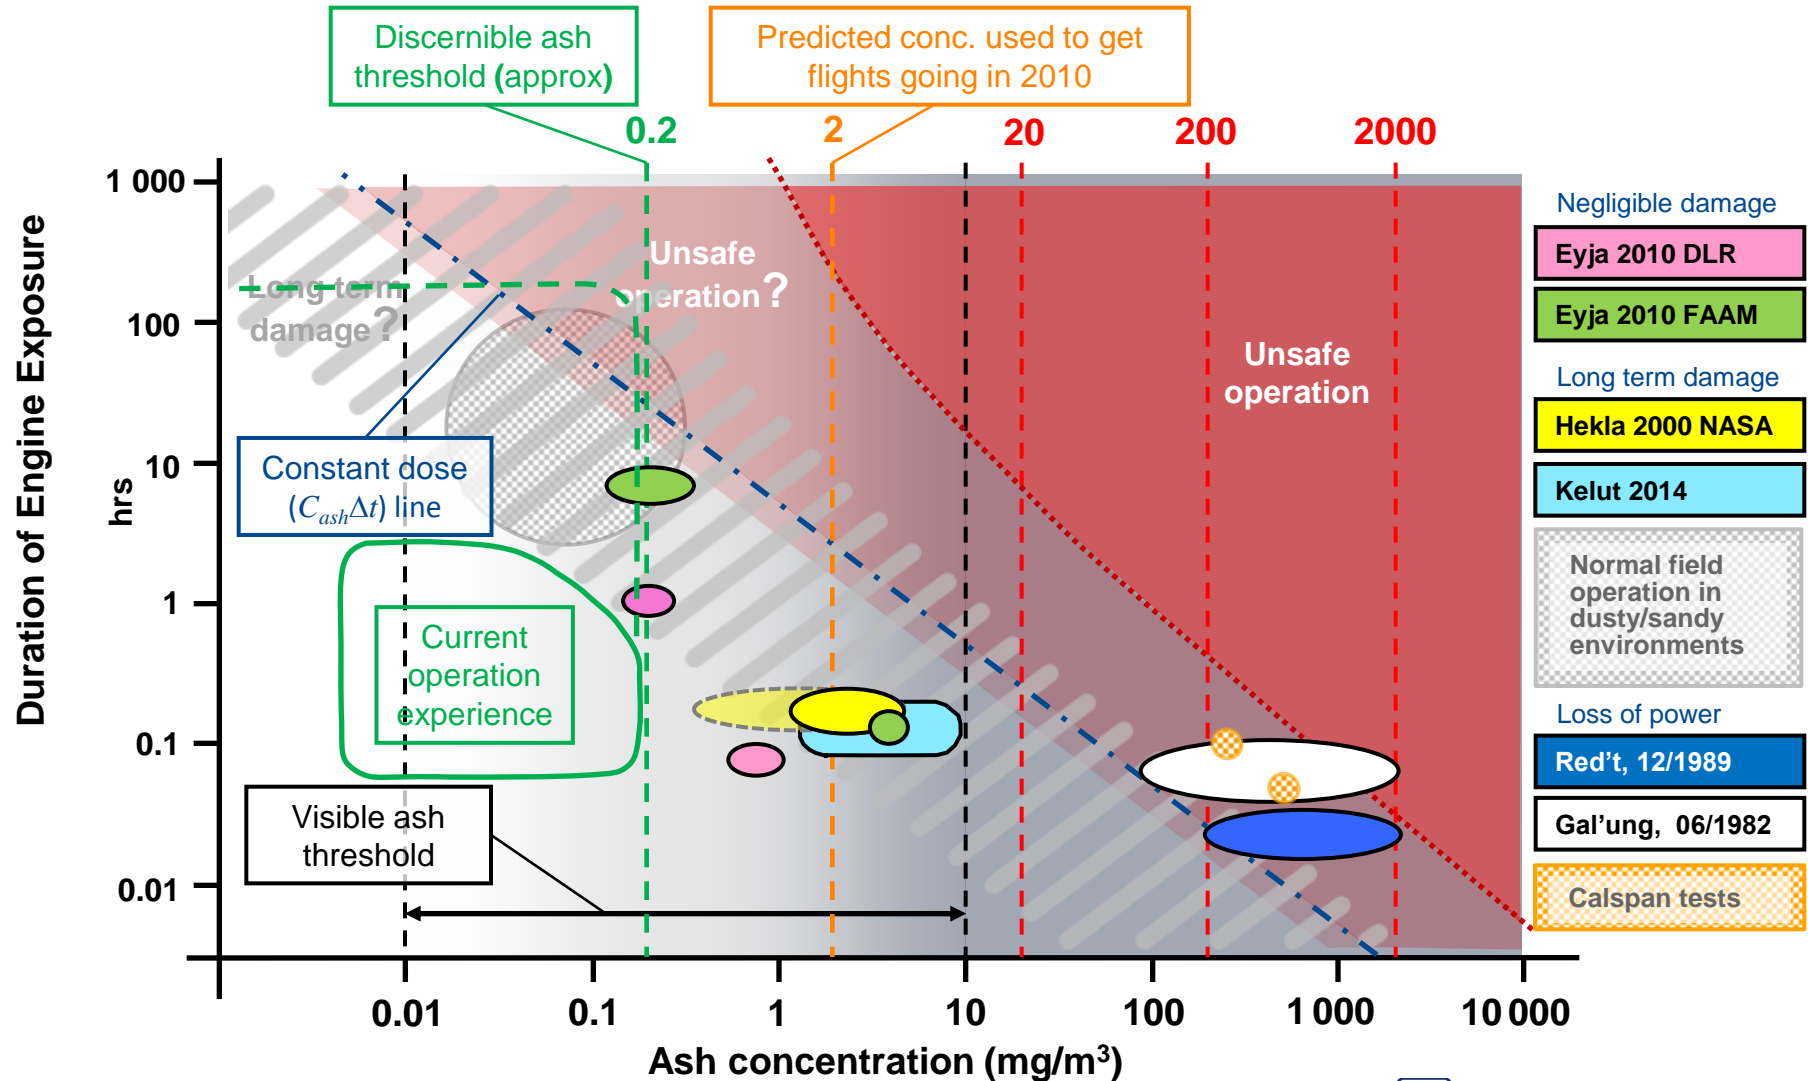
Engine Susceptibility

- Effectively no susceptibility up to discernible (i.e. $\sim 0.2 \text{ mg/m}^3$)

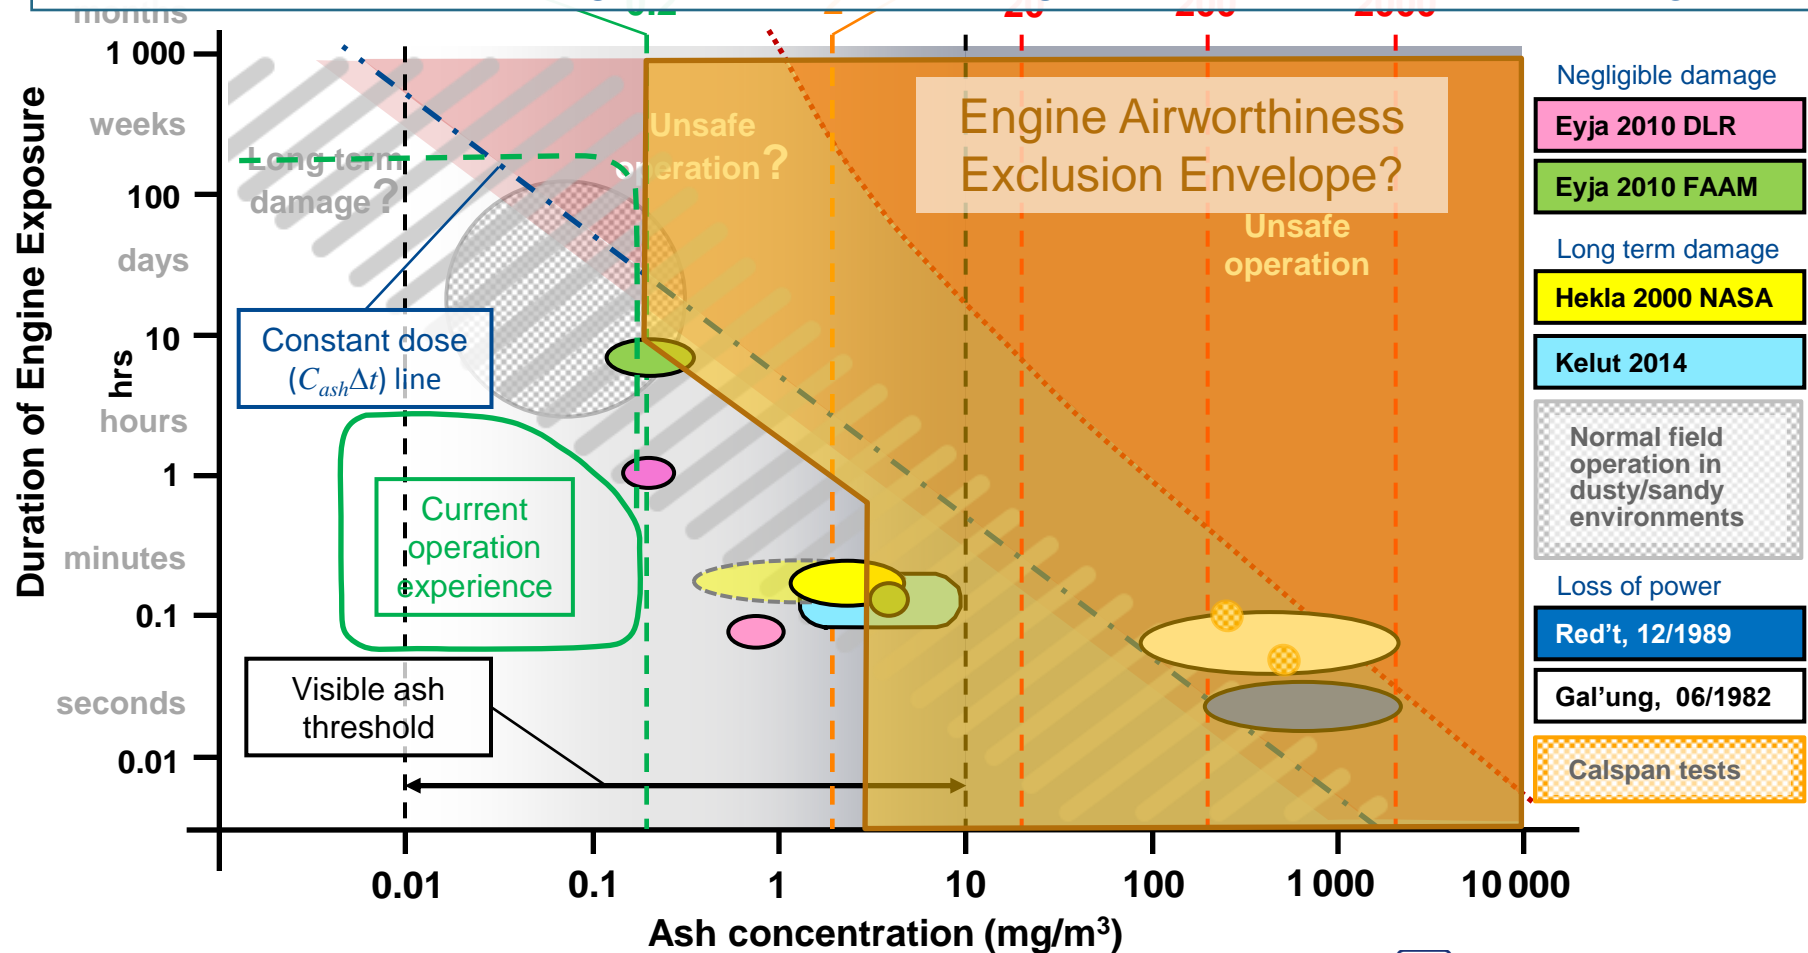
Engine Susceptibility – Airlines' Requests

- Why not use a number? e.g. x mins at 4 mg/m^3 or equivalent dose at lower concentrations
 - i.e. $2x$ mins at 2 mg/m^3 , $4x$ mins at 1 mg/m^3 , ..., to unlimited at 0.2 mg/m^3

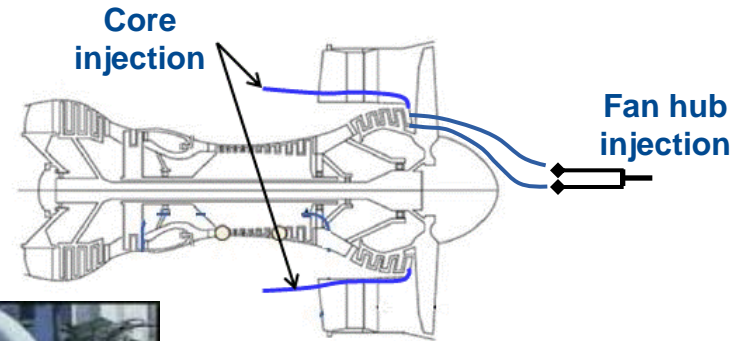
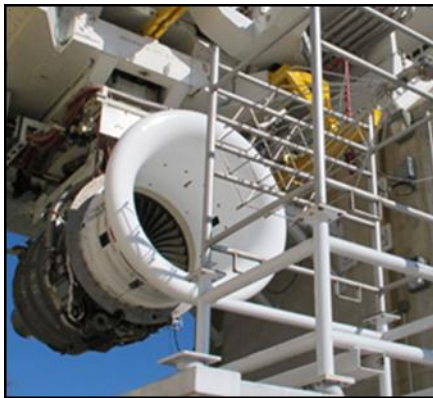
CFMI sand test

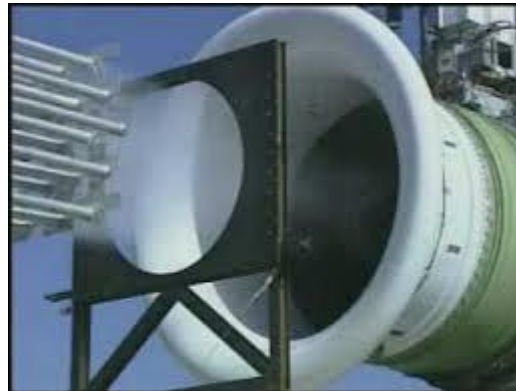
GE90 hail test – similar set up used for sand testing

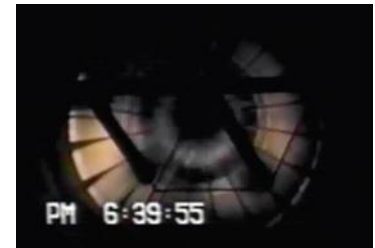
CALSPAN dust test

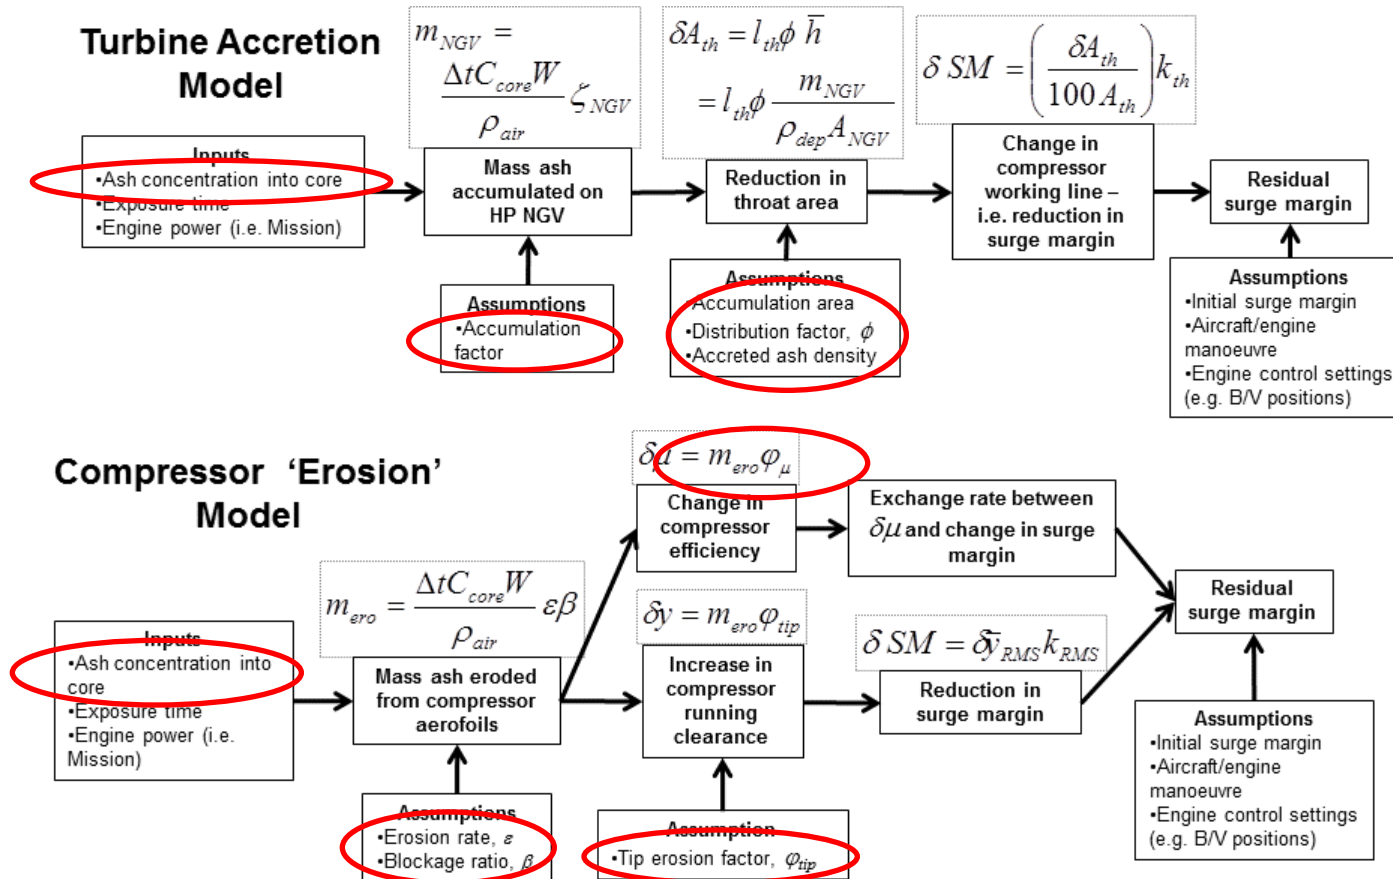
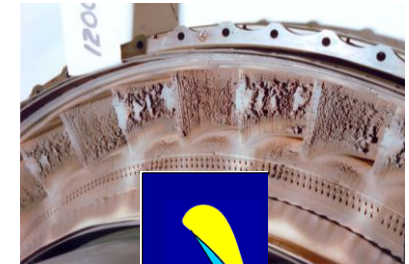
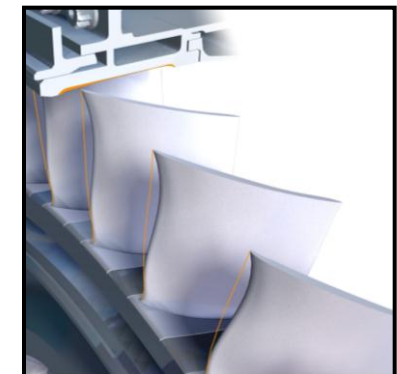
CS-E 1050 Compliance – Analysis

- High level engineering correlation based approach

High uncertainty

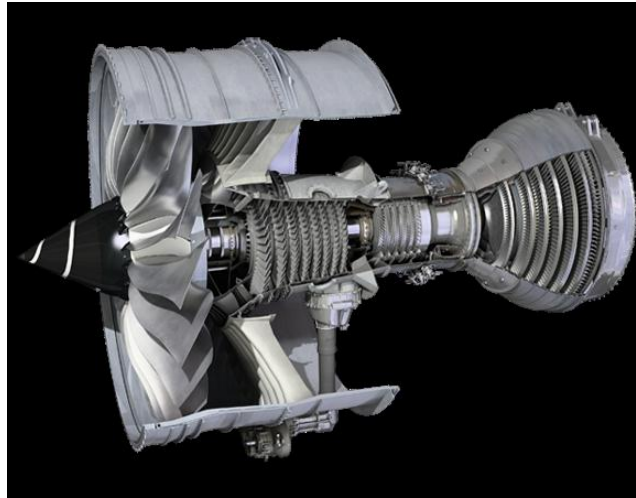
- Trent 1000

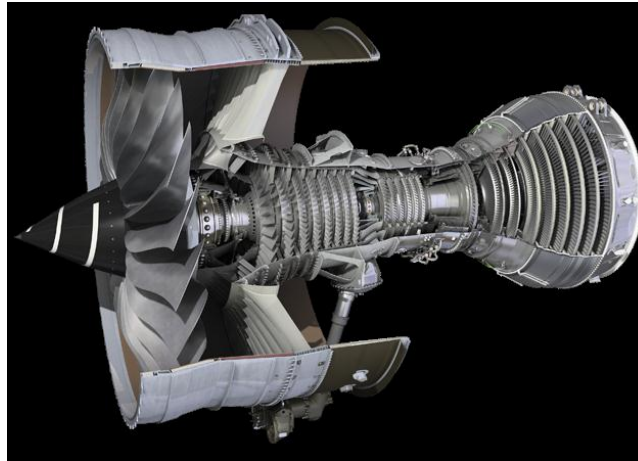
- Trent XWB
